Manhole Inspection Summary

Manhole # S21G__001MH

Location Address: **26 ADDISON ST** Cross Street: **FAYETTE-FAIRMOUNT**

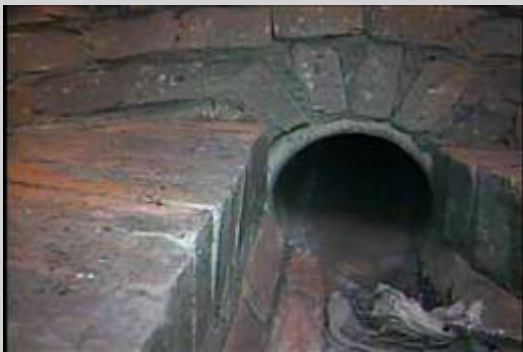
12 O'Clock Outflow

8 in. Circular Gravity Sewer
Pipe Out @ 12 O'Clock

Pipe Height: **8.4** (in.) Rod and Bar (Angled)
Pipe Material: **Clay** ☐ Pipe Lined
Invert Depth: **5.70** (ft.) Flow Characteristics: **Fast**
Deposits: ☒ None ☐ Mud ☐ Sludge ☐ Debris ☐ Grease
Silt Depth: (in.) Deposits Extent:
Infiltration: **None** Pipe Seal Cond: **Sound**

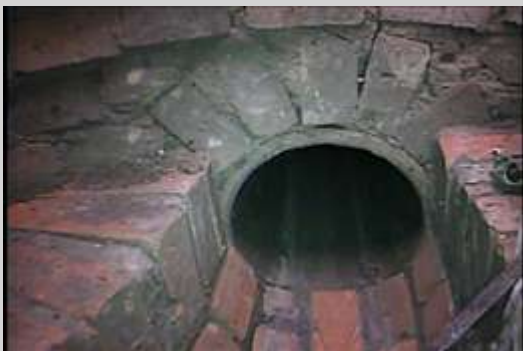
3 O'Clock Inflow

8 in. Circular Gravity Sewer
Pipe In @ 3 O'Clock

Pipe Height: **7.2** (in.) Rod and Bar (Angled)
Pipe Material: **Clay** ☐ Pipe Lined
Invert Depth: **5.37** (ft.) Flow Characteristics: **Fast**
Deposits: ☒ None ☐ Mud ☐ Sludge ☐ Debris ☐ Grease
Silt Depth: (in.) Deposits Extent:
Infiltration: **None** Pipe Seal Cond: **Sound**
